1.4.5 L'effet de l'humidité	27
1.5 Conclusion	29
CHAPITRE 2 EFFECT OF SURFACE DEGRADATION ON SLOT PARTIAL DISCHARGE ACTIVITY UNDER ELECTRICAL, THERMAL AND MECHANICAL STRESSES	31

En conséquence, une vaste étude sur le phénomène des DP d'encoche a été démarrée en janvier 2007 et réalisée en étroite collaboration entre l'École de technologie supérieure (ÉTS) et l'Institut de recherche d'Hydro-Québec (IREQ). L'objectif principal de cette étude est de contribuer à l'amélioration des connaissances d'un des mécanismes les plus néfastes pour les alternateurs, soit celui des DP d'encoche. Cette étude considère l'effet de paramètres tels que la condition des surfaces ainsi que la présence des contraintes électriques, thermiques, mécaniques et environnementales présentes durant le fonctionnement des machines sur

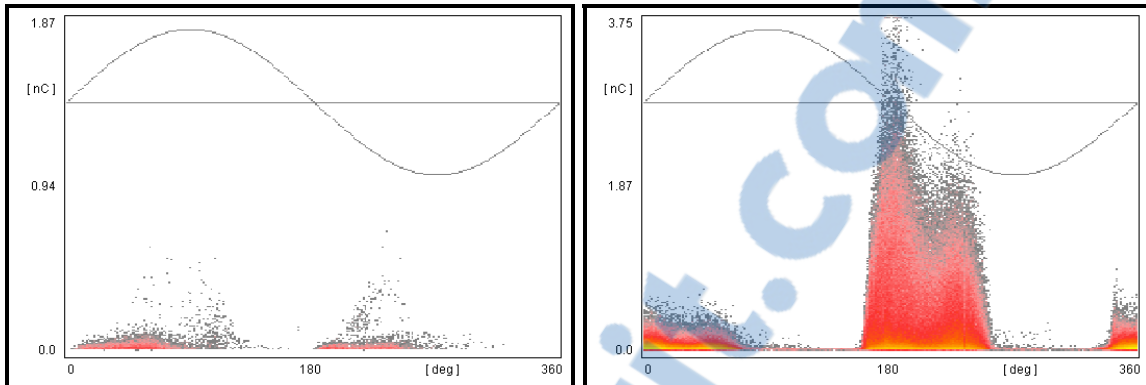
Figure 2.14 PRPD patterns measured on the entire bar 3A at 8 kV with the capacitive coupler and at room temperature condition, after 5800 h (left) and after 7200 h (right)

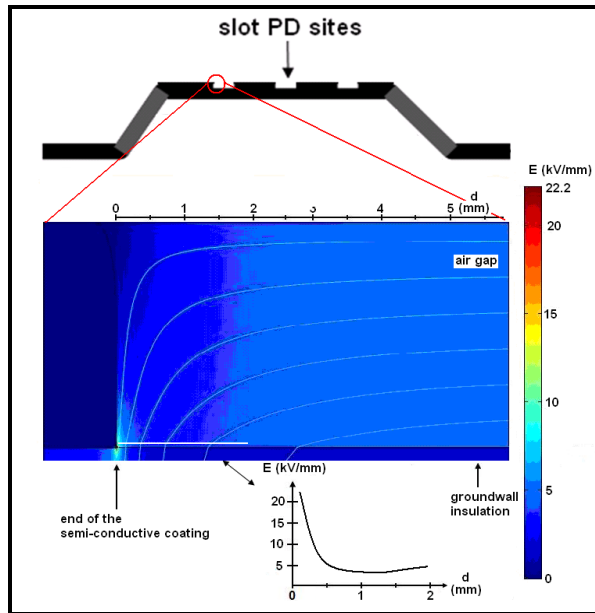
Figure 2.16 Electric field and equipotential surface calculation inside an air gap between epoxy-mica surface insulation and grounded steel electrode (E is the magnitude of the electric field)

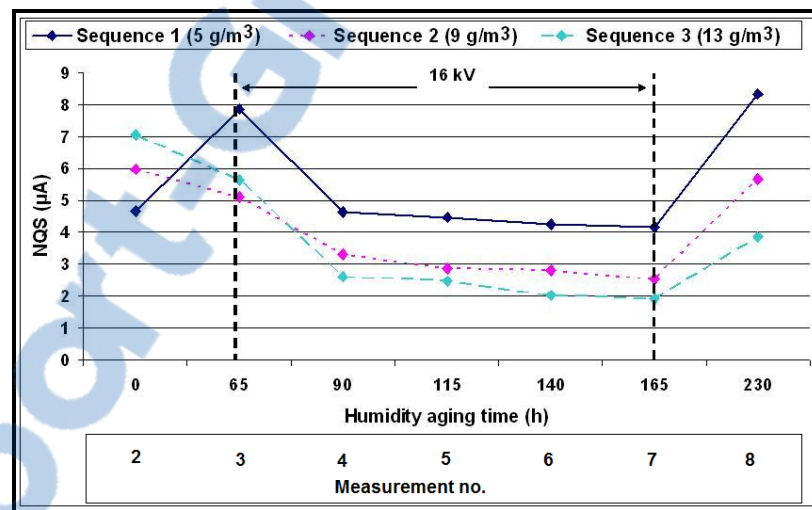
Figure 3.14 Evolution of the NQS of the slot PD site of bar B measured at 8 kV and 85°C for all aging sequences

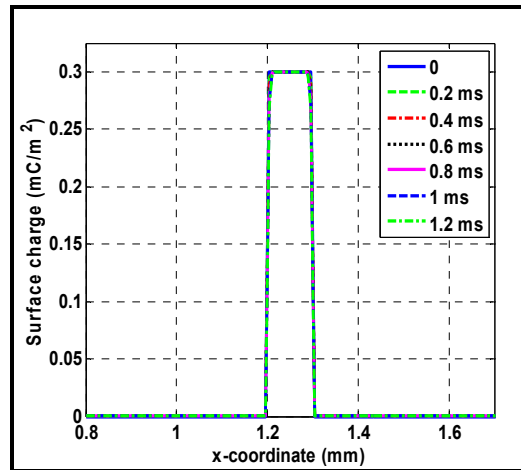
Figure 4.8 Surface charges for insulation surface conductivity of 10^{-16} S per square

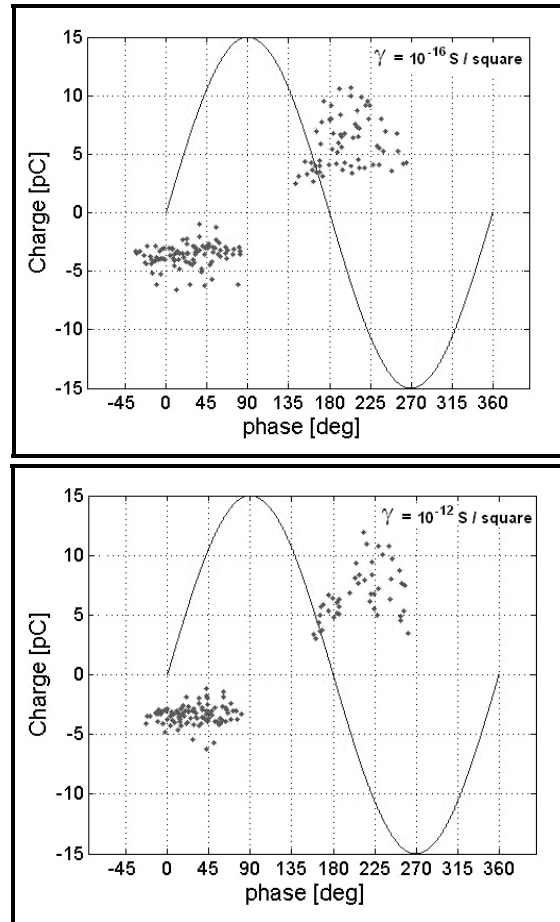
Figure 4.11 Distribution of PD events as a function of the applied voltage phase with $\phi_{\text{cond}} = 1.5 \text{ eV}$, $\phi_{\text{insul}} = 1.3 \text{ eV}$ and $\gamma = 10^{-16} \text{ S per square}$ (top); $\gamma = 10^{-12} \text{ S per square}$ (bottom)

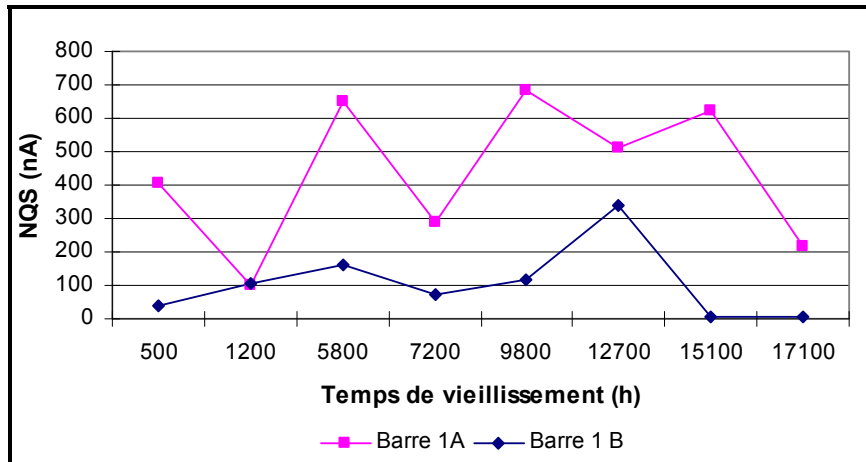
Figure 5.5 L'évolution des mesures de DP effectuées avec un coupleur capacitif à 8 kV à la température ambiante

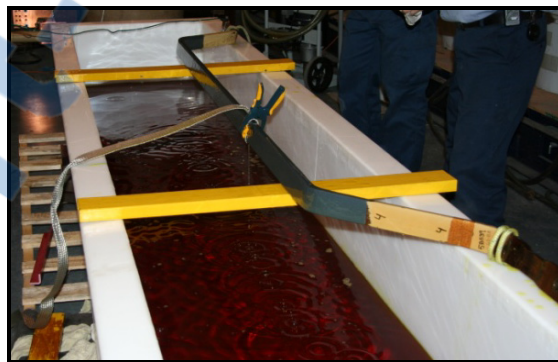
Figure 5.14 Le montage utilisé lors de l'essai de rupture diélectrique
